Manhole Inspection Summary

Manhole # S13M__002MH

Insp Date: **1/21/09 10:19 AM**

Location Address: **200 Font Hill Ave.**

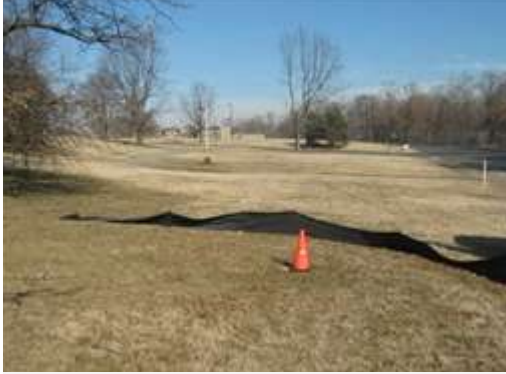
Location View

Comments **Located on the SEED School of Maryland property**

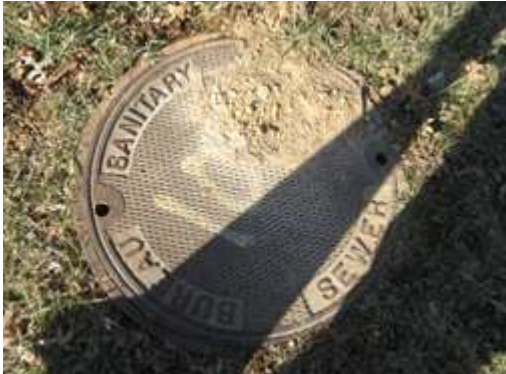
MH Lid

Cover Shape: **Circular** Diameter: **25.** (in.) Length: **0** (in.) Dist A/B Grade: **0** (in.)
75

Type: **Sanitary** Condition: **Sound** Cover Material: **Cast Iron**

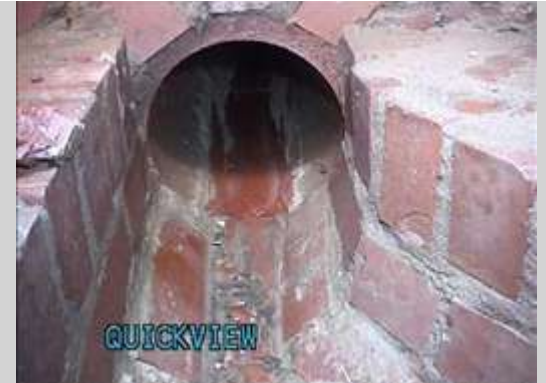
12 O'Clock Outflow

8 in. Circular Gravity Sewer
Pipe Out @ 12 O'Clock

Pipe Height: **7.2** (in.) Rod and Bar (Angled)
Pipe Material: **Unknown** ☐ Pipe Lined
Invert Depth: **5.02** (ft.) Flow Characteristics: **None**
Deposits: ☒ None ☐ Mud ☐ Sludge ☐ **Debris** ☐ Grease
Silt Depth: **0** (in.) Deposits Extent:
Infiltration: Pipe Seal Cond:

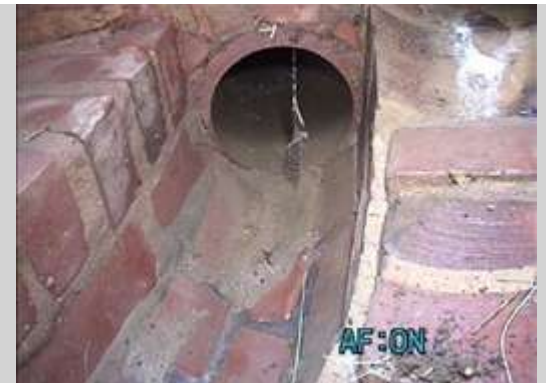
3 O'Clock Inflow

8 in. Circular Gravity Sewer
Pipe In @ 3 O'Clock

Pipe Height: **8.4** (in.) Rod and Bar (Angled)
Pipe Material: **PVC** ☐ Pipe Lined
Invert Depth: **3.98** (ft.) Flow Characteristics:
Deposits: ☐ None ☐ Mud ☐ Sludge ☐ **Debris** ☐ Grease
Silt Depth: **0** (in.) Deposits Extent:
Infiltration: Pipe Seal Cond:
